United States Environmental Protection Agency Environmental Sciences Division P.O. Box 93478 Las Vegas, NV 89193-3478 TS-PIC-20506006S November 2004

AERIAL PHOTOGRAPHIC ANALYSIS OF DEVIL'S SWAMP LAKE SITE Scotlandville, Louisiana

EPA Region 6

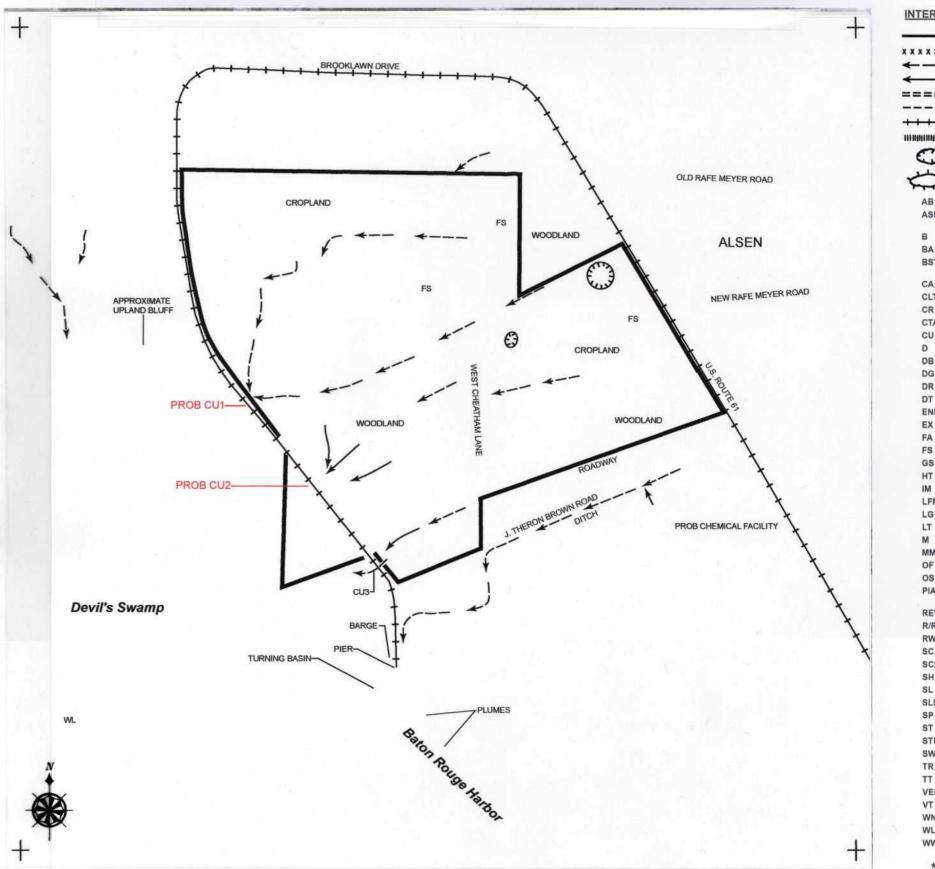
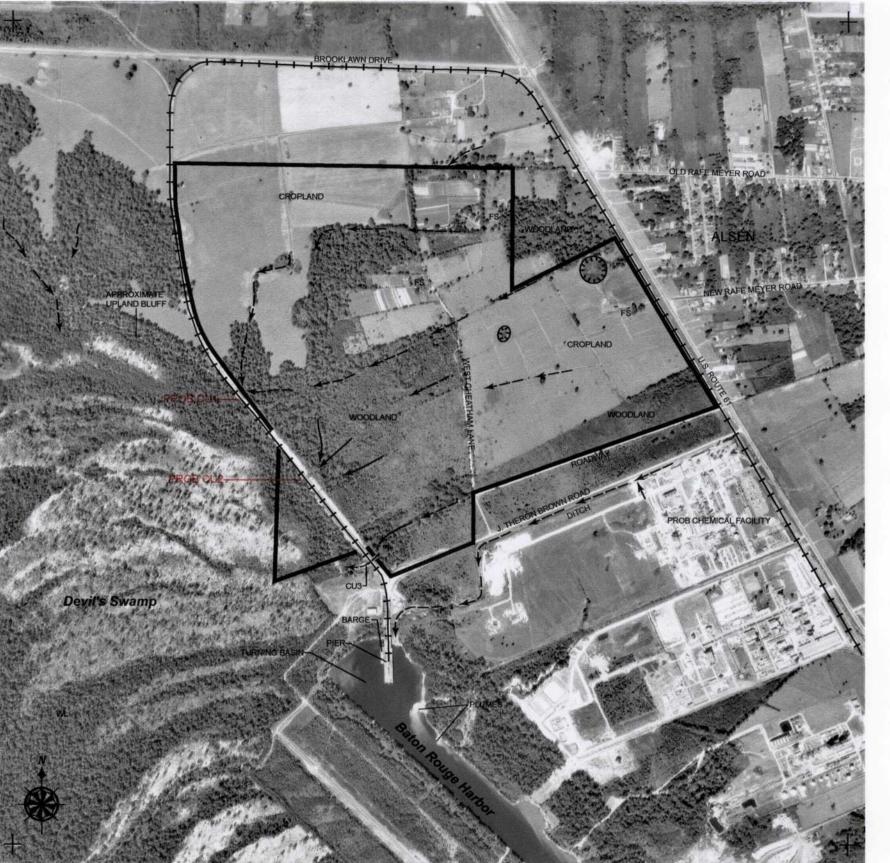
Figure 7. Rollins Environmental Services (LA), Inc. site, September 27, 1968. Approximate scale 1:12,900.

This 1968 photograph shows the condition of the area later occupied by Rollins Environmental Services (LA), Inc., (RES) facility prior to its industrial development. The RES site consists of an upland area and a swamp area along the east bank of the Mississippi River. The upland portion of the RES site is adjacent to the community of Alsen, Louisiana, and is occupied by farmsteads with associated houses and/or barns (FS) and agricultural land consisting of cropland and/or pasture. Woodlands are also observed within the site. Dense woodlands are observed along the western edge of the site and obscure a bluff along the east bank of the Mississippi River's flood plain and the adjacent Devil's Swamp.

The railroad line along the west perimeter of the RES site follows the bluff along the Mississippi River bank. The observed natural drainage patterns within the site trend to the southwest and under the railroad line via culverts (CU). The drainage then enters the adjacent Devil's Swamp and eventually the

Mississippi River to the southwest. The presence of two of these probable culverts (CU-1 and CU-2) is detected by the observed terrain topography within the site but their locations are approximate due to vegetation obscuring the view. Culvert CU-3 near the southwest corner of the site is visible. The probable culverts are not annotated on every subsequent date of photography. The runoff patterns within the Devil's Swamp wetland are not generally distinct due to the water inundation from periodic high river levels; however, the meandering channel of Bayou Baton Rouge (not annotated) trends south through Devil's Swamp.

J. Theron Brown Road runs parallel to the south boundary of the RES site. This road and a parallel railroad serve a pier at the Baton Rouge Harbor Turning Basin situated southwest of the site. A large drainage ditch visible south of the road carries runoff from a probable chemical facility, located south of the site, directly into the Baton Rouge Harbor.

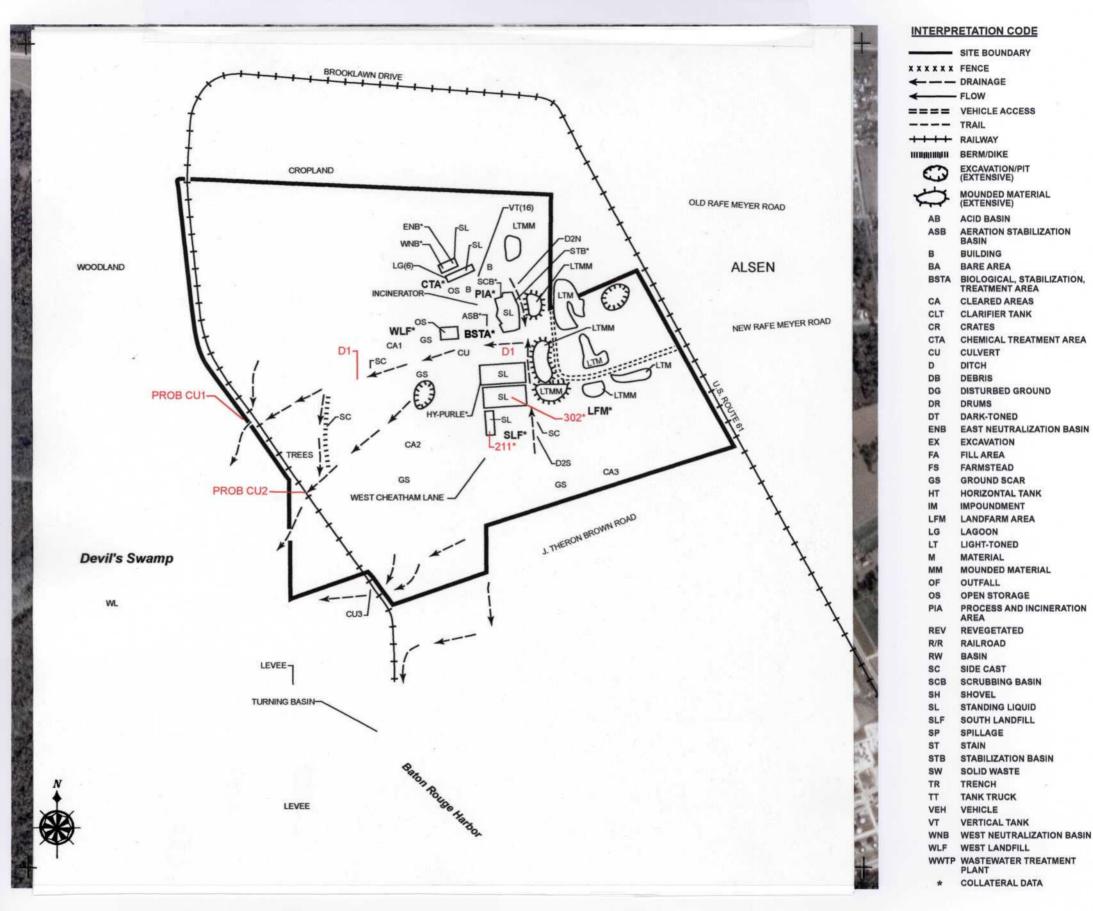
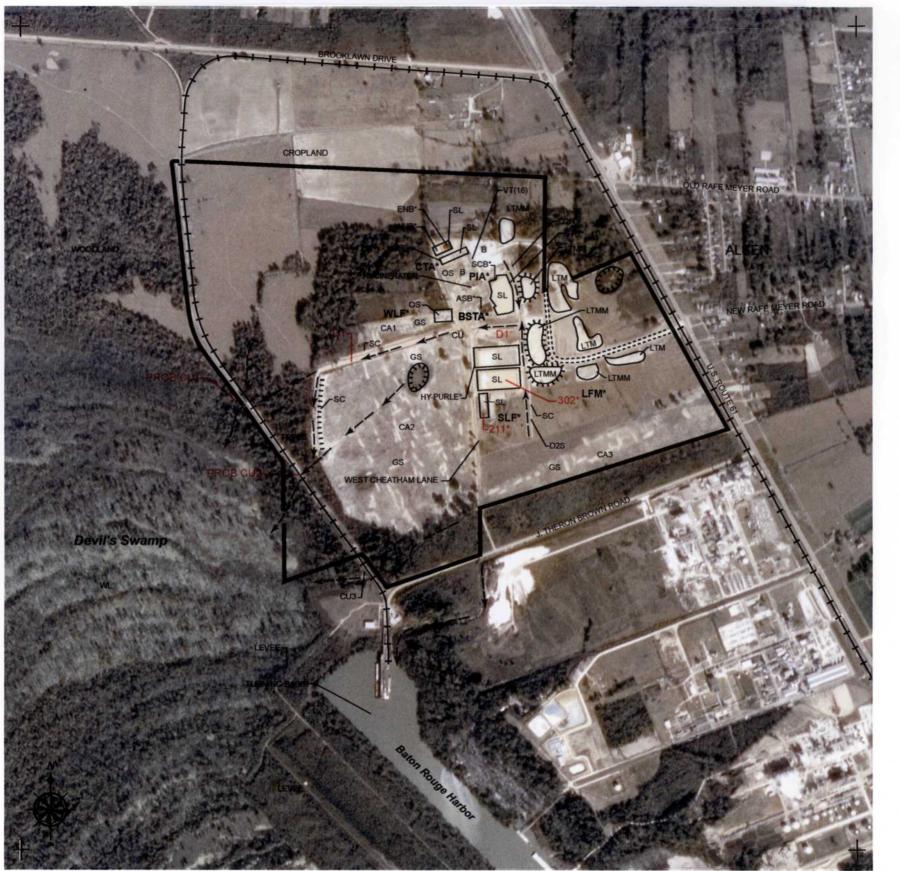
Figure 8. Rollins Environmental Services (LA), Inc. site, November 24, 1970.

The natural drainage patterns noted around the RES facility trend southwest toward Devil's Swamp via probable culverts (CU1, CU2) under the railroad along the west perimeter of the site. The termini of these natural drainageways are obscured by the dense woodland along the bluff adjacent to the swamp.

A drainage ditch (D1) has been dug between the RES facility and Devil's Swamp. The mound of light-toned sidecast (SC) is noted along the rim of the ditch and reveals the ditch has been excavated. The contents of the ditch appear to eventually reach Devil's Swamp via probable culvert (CU2). Within the RES facility ditch D1 receives drainage from two additional ditches (D2N and D2S) that flow perpendicular to ditch D1. These tributary ditches are located east of West Cheatham Lane.

The CTA, the west neutralization basin* (WNB*) and the east neutralization basin* (ENB*) are visible and both contain liquid. A group of six adjacent lagoons (LG), only three of which appear to contain liquid (not annotated), is noted to the south of the WNB and the ENB. A group of sixteen processing/storage vertical tanks (VT, not all annotated) is to the east of the group of lagoons. This group of processing/storage vertical tanks will be simply referred to as vertical tanks on subsequent dates of photography unless observed conditions change. Drainage (not annotated) from this portion of the site appears to trend southeast toward ditch D2N.

Within the PIA are observed buildings (B, not all annotated), an incinerator* from which a smoke plume is visible, and an open storage area (OS). Drainage (not annotated) from this portion of the site appears to flow south into the section of ditch D1 located on the east side of West Cheatham Lane.

Within the BSTA a stabilization basin* (STB*), a scrubbing basin* (SCB*), and an aeration stabilization basin* (ASB*) are observed. Drainage (not annotated) from this portion of the site appears to flow east into the section to ditch D2N. Liquid holding cells (Hy-Purle*, 302*) are visible to the south of the STB. A smaller liquid holding feature is noted near the southwest corner of Cell 302; this feature appears to occupy the location of Cell 211*. Drainage (not annotated) from this portion of the site appears to flow east into the section of ditch D2S.

Within the LFM area are three deposits of light-toned material (LTM) and five large mounds of light-toned material (LTMM) are visible along the access road. The source of these light-toned deposits is not evident. Drainage from this section of the site trends west toward ditches D2N and D2S.

The clear area (CA2) observed south of ditch D1 and the clear area (CA3) observed south of the access road into the RES facility both contain ground scars (GS). No waste disposal activity is discerned at these locations. These areas will not be discussed on subsequent dates of photography unless waste disposal activity in noted.

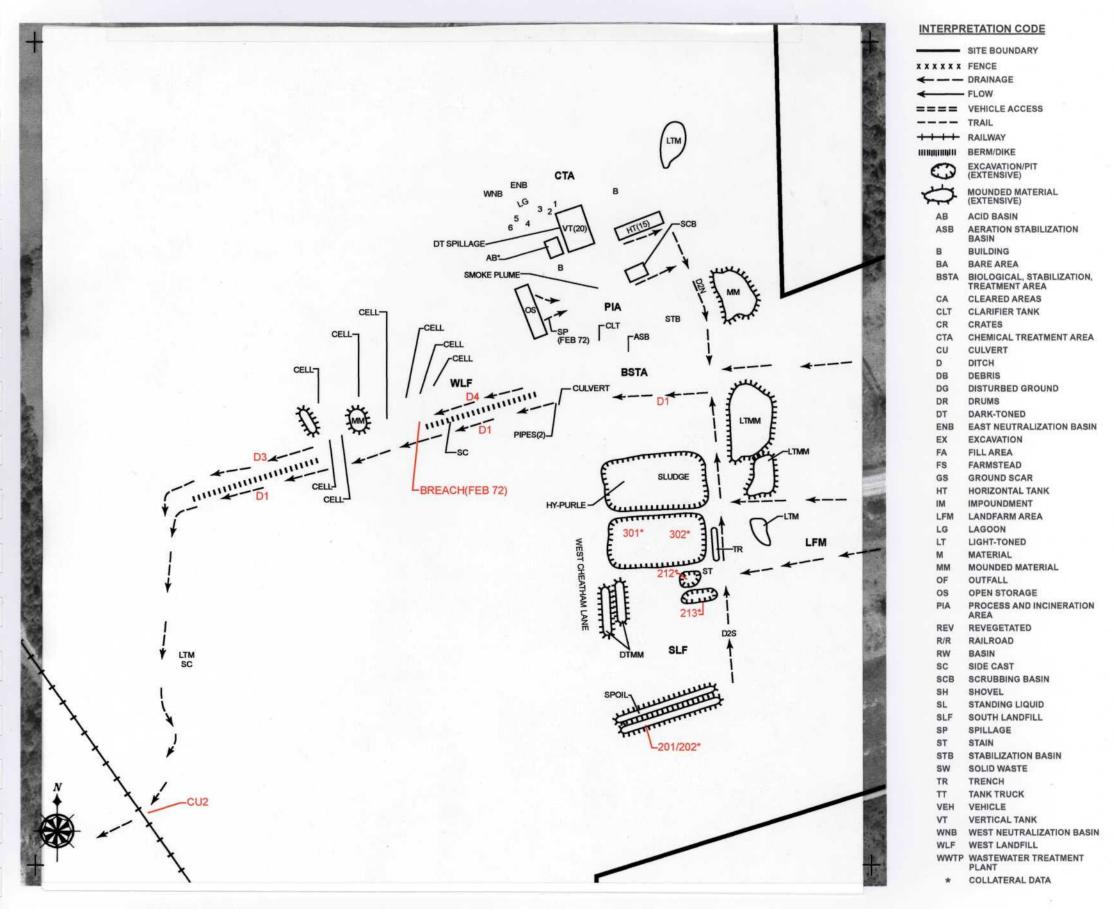
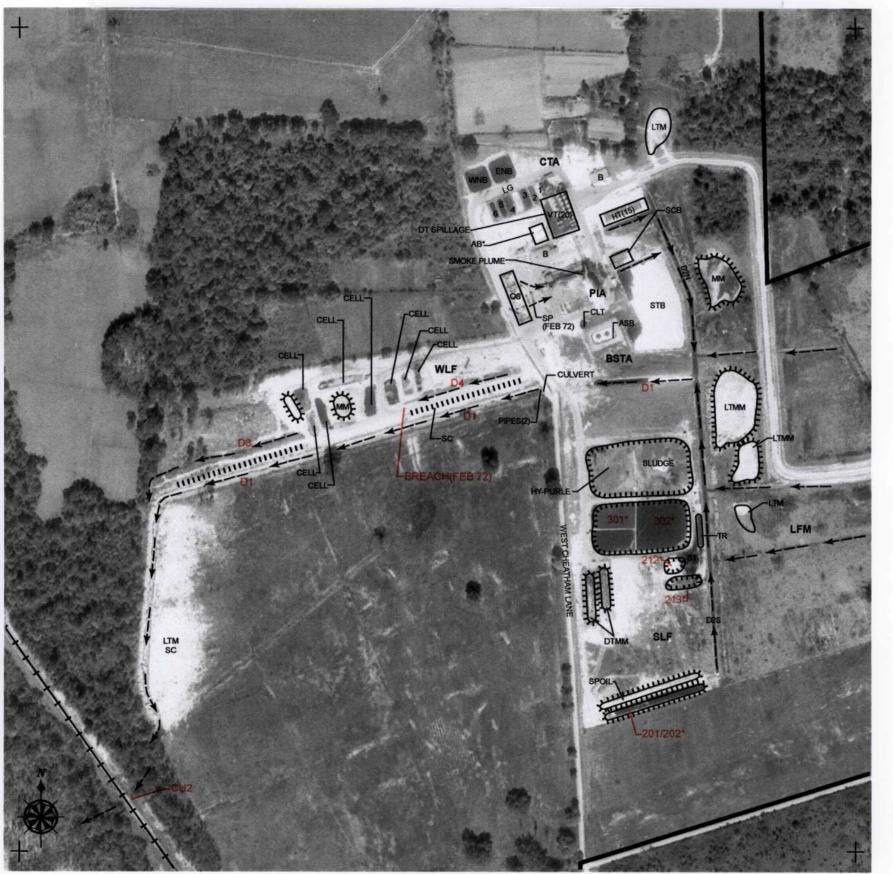
Figure 9. Rollins Environmental Services (LA), Inc. site, April 1, 1972. Approximate scale 1:4,800.

Two pipes are discerned emerging from the West Cheatham Lane culvert that discharge into ditch D1. The section of D1 east of this culvert continues to receive inflows from ditches D2N and D2S. A tributary ditch that empties into ditch D2N is observed running along the south side of a group of fifteen horizontal storage tanks (HT) on the northeast side of the PIA. These tanks have no secondary containment, thus leakage or spillage from these storage tanks could enter ditch D2N via this tributary ditch.

Potential sources of contamination are noted at the CTA. The group of six adjacent lagoons (1* through 6*) all appear to contain dark-toned liquid. The presence of bottom lining material could not be discerned in any of these lagoons. A secondary containment berm is now discerned around the group of twenty vertical tanks and dark-toned spillage/leakage is visible within this structure. An acid basin* (AB*) containing a light-toned liquid is visible along the west side of the secondary containment berm for these vertical storage tanks. The presence of bottom lining material could not be discerned in the AB.

Within the PIA a smoke plume is observed over the incinerator (not annotated) indicating it remains operational. Containers and possible tank trucks were discerned at a large open storage area west of the incinerator. The spillage (SP) or a discharge observed from four of these possible tank trucks, on the February photograph, flowed toward the incinerator.

The SLF has been established south of Cells 301 and 302 where several cells (201/202*, 212*, and 213*) have been dug. The presence of bottom lining material could not be discerned in any of these cells. Two mounds of darktoned material are visible to the southwest of Cell 301. A dark-toned ground stain is visible near the southeast corner of Cell 302. An open trench has been dug along the east side of Cell 302. Surface runoff (not annotated) from the SLF drains into ditch D2S and appears to flow north to the section of ditch D1 located on the east side of West Cheatham Lane.

The WLF has undergone significant earthmoving activity since 1970. The open storage area west of the PIA, noted in 1970, is no longer apparent. Several cells are discerned in this section of the RES facility. All of these cells contain dark-toned liquid or sludge and a presence of bottom lining material could not be discerned. Shallow segments of ditches D3 and D4 are discerned in this west landfill and flow southwest and parallel to the ditch D1. A breach in the berm along the north side of ditch D1 allows runoff from ditch D4 to enter ditch D1. This breach is best seen on the February photograph. Ditch D3 empties into ditch D1 at the westernmost extent of ditch D1, as ditch D1 changes flow direction from southwest to south. Light-toned sidecast is observed along the rim of the southern portion of ditch D1 perhaps indicating it has been re-excavated since 1970.

No discernible significant activity is noted at the landfarm* (LFM*) southeast of the PIA. The deposits of light-toned material and mounds are still visible along the access roadway into the RES facility. Since 1970 one of the mounds appears to have become partially revegetated. The source of the light-toned deposits is not evident. Surface runoff from the LFM flows west into D2S and D2N located east of West Cheatham Lane.

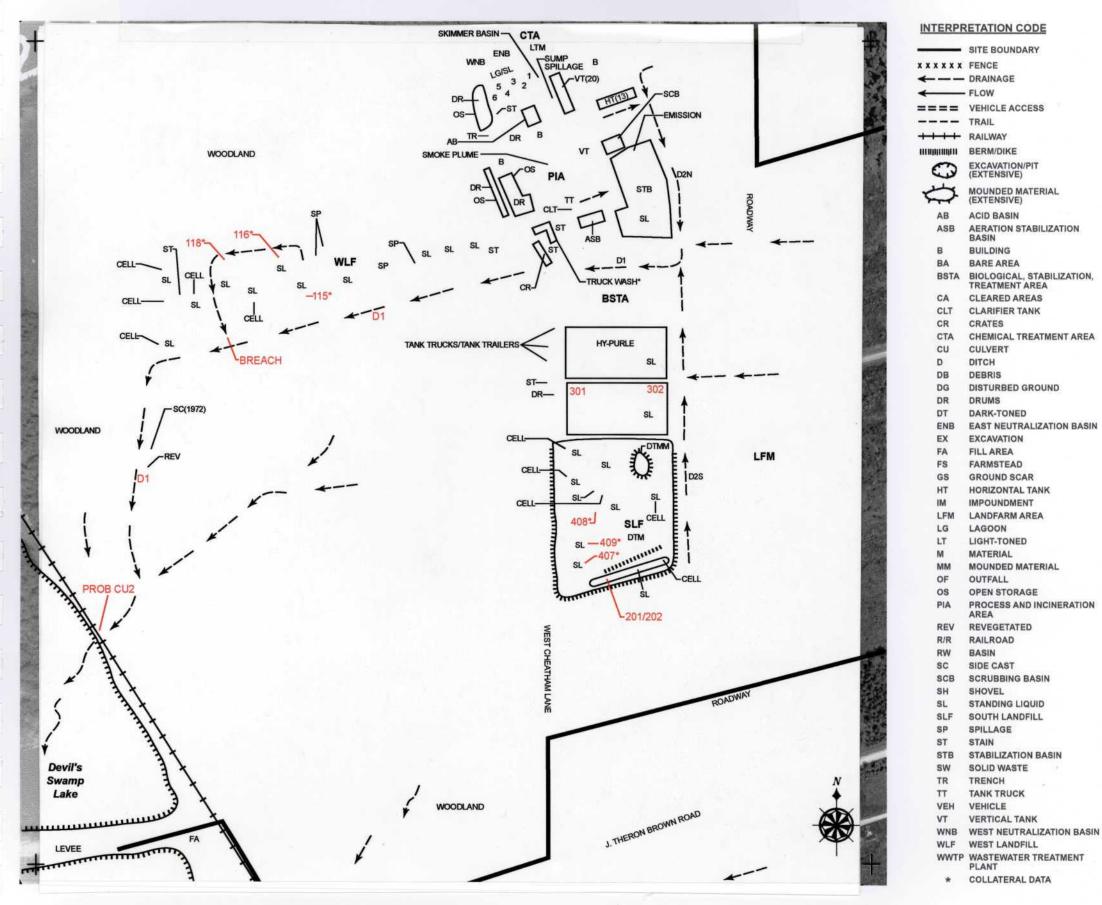
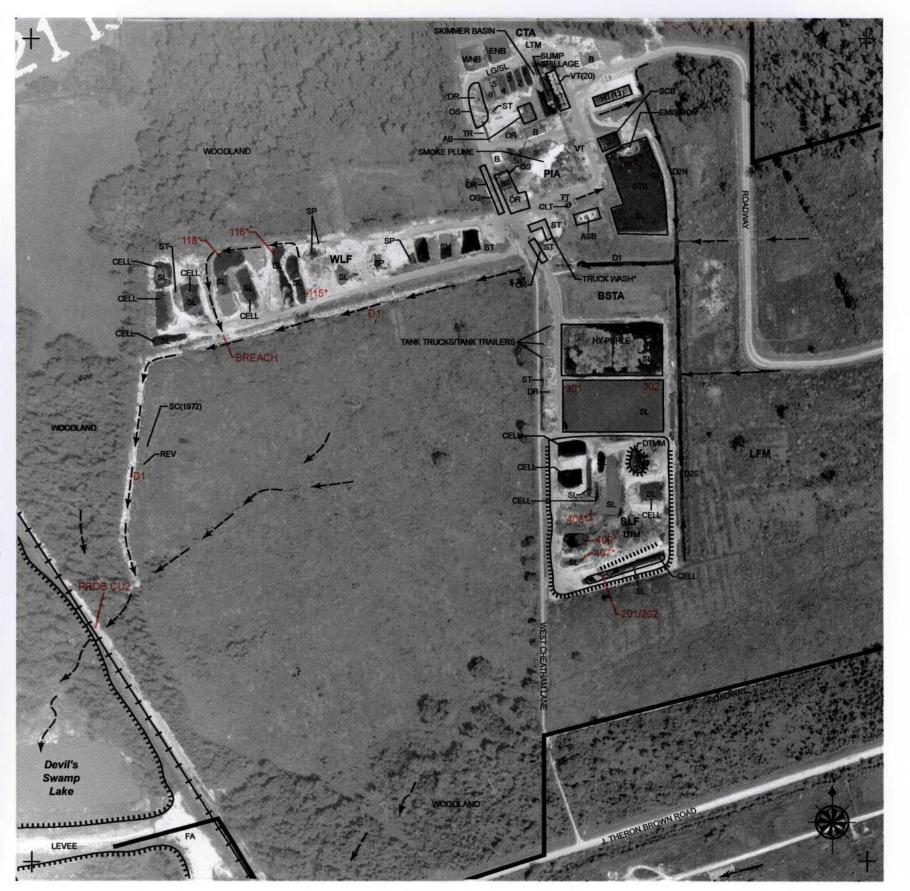
Figure 10. Rollins Environmental Services (LA), Inc. site, September 21, 1975. Approximate scale 1:4,650.

Within the CTA liquid is still noted in the WNB, ENB, AB, and within the group of adjacent lagoons. Dark-toned spillage/leakage is still observed within the secondary containment berm of the group of twenty vertical tanks. A sump appears to have been dug on the west side of this berm increasing the holding capacity of the secondary containment system. Additional tanks (not all annotated) have been installed at the PIA while the number of horizontal tanks in a group, compared to those noted on the 1972 photograph, has been reduced.

At the PIA a smoke plume remains visible over the incinerator (not annotated, obscured by smoke). Several open storage areas containing large accumulations of 55-gallon drums are observed along the west side of the PIA. Dark-toned stains (not all annotated) from possible spillage and/or leakage from these drums are visible and reveal poor housekeeping practices.

The basins at the BSTA appear to remain operational. An emission is noted near the north bank of the STB. Since 1972 an irregularly shaped truck wash* pond has been established south of the PIA. The Hy-Purle cell continues to contain sludge. Cell 301 and Cell 302 have merged into one large cell that holds a dark-toned liquid. Several tank trucks and tank trailers are parked

along the west side of the Hy-Purle cell. A group of probable 55-gallon drums and a dark-toned ground stain from spillage or leakage are observed along West Cheatham Lane.

The SLF has undergone additional earthmoving resulting in several cells being opened, all of which contain dark-toned liquid. The dark-toned mounded material observed at this location on the 1972 photo is absent. The large irregularly shaped Cell 408*, which holds a dark-toned liquid, has been excavated in this location. The open cells noted near the southeast corner of Cell 302 in the 1972 photograph appear to have been filled and closed. Darktoned mounded material is noted throughout the SLF. To the south of this mound another cell containing a dark-toned liquid has been opened. South of Cell 408, two smaller cells (407* and 409*) have been opened. Cell 409 contains a dark-toned liquid and objects (not annotated), probable 55-gallon drums, floating on the surface of the liquid. The long shaped Cell 201/202* is observed along the south end of the SLF and contains a dark-toned liquid and objects, possible 55-gallon drums, floating on the surface of the liquid. All of the cells contain dark-toned liquid or sludge and a presence of bottom lining material could not be discerned. Surface runoff from the SLF appears likely to flow east into the adjacent ditch D2S.

Extensive earthmoving has occurred in the WLF; several new cells have been opened and some cells noted in 1972 are no longer evident. The containment berm around Cell 115* appears breached allowing leakage to flow west around Cell 118* and then south into ditch D1. All of the cells contain dark-toned liquid or sludge and a presence of bottom lining material could not be discerned. Spillage and or ground stains (not all annotated) are also observed adjacent to several of these cells indicating poor housekeeping practices.

No significant activity is noted within the LFM and the deposits of lighttoned material and mounded material noted along the access roadway appear revegetated.

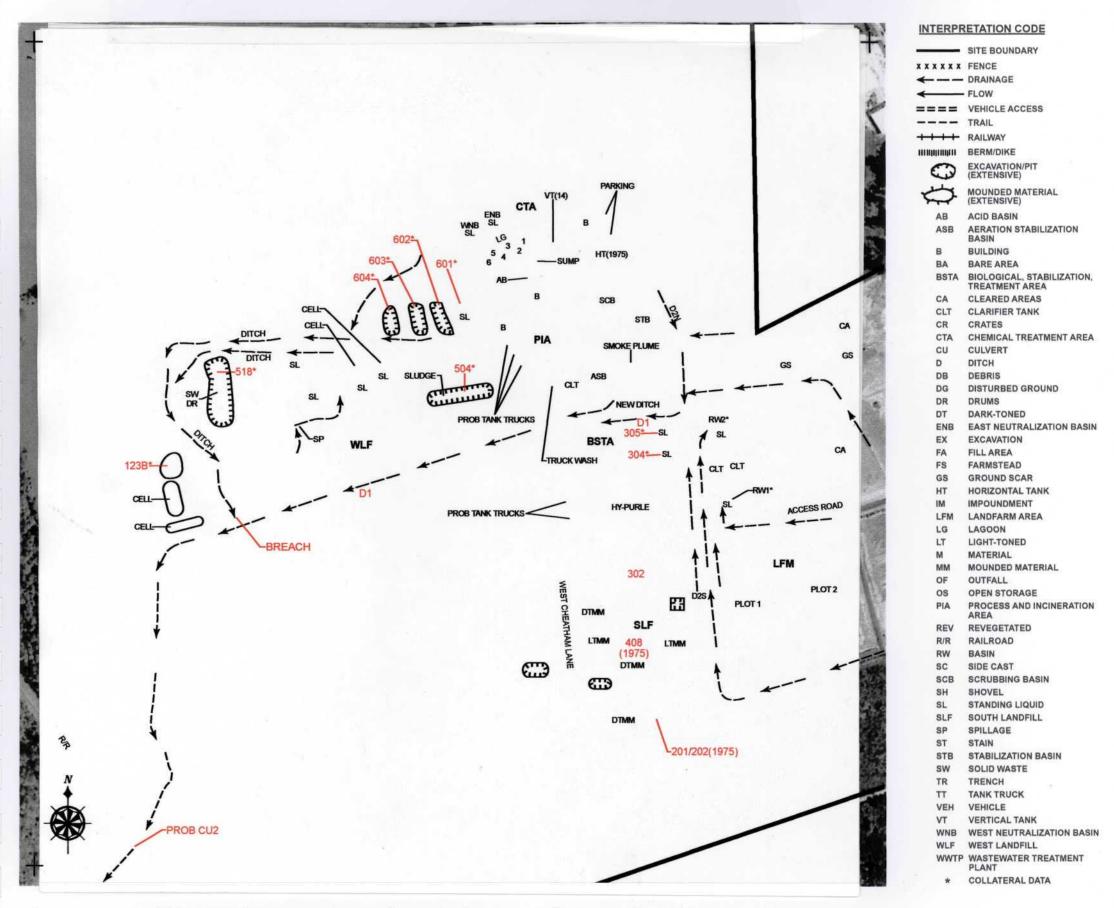
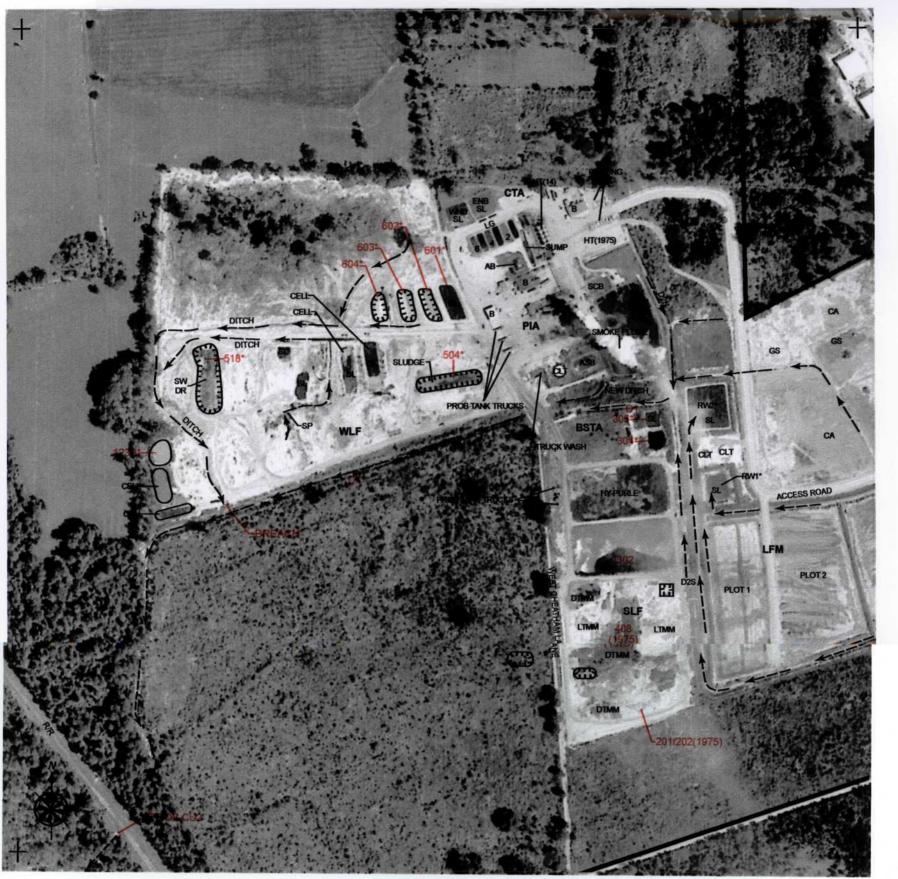
Figure 11. Rollins Environmental Services (LA), Inc. site, April 19, 1978. Approximate scale 1:5,000.

Within the CTA liquid is still noted in the basins WNB, ENB, AB, and within the group of adjacent lagoons. Fourteen processing/storage vertical tanks are now discerned of the group of twenty tanks that were visible in 1975, revealing that six tanks have been removed. The sump pit to the west of these vertical tanks contains dark-toned spillage/leakage. The spillage/leakage within the secondary containment structure appears to have been directed into the sump pit. The group of thirteen horizontal storage tanks noted to the east of the vertical tanks have been removed.

Several probable tank trucks are observed along the west side of the PIA. A visible smoke plume over the incinerator (not annotated) indicates the incinerator remains operational. The open storage areas with 55-gallon drums observed along the west side of the PIA on the 1975 photograph, are no longer evident and appear to have been removed. The dark-toned ground stains noted in 1975 next to many of the drums are also no longer evident, suggesting improved housekeeping practices.

Within the BSTA a new drainage ditch which empties into ditch D1 has been dug near the southwest corner of the basin STB. Another clarifying tank has been installed between the basin ASB and the irregular-shaped truck wash pond. Two new cells (304*, 305*) containing liquid have been opened north of the Hy-Purle cell. The presence of bottom lining material could not be discerned within these cells. The Hy-purle cell continues to hold sludge and Cell 302 continues to hold a dark-toned liquid. Several probable tank trailers are observed along the west side of the Hy-Purle cell. The probable 55-gallon drums and a dark-toned ground stain noted along West Cheatham Lane on the 1975 photograph are not evident.

Within the SLF several cells observed in 1975, including Cell 408 that contained dark-toned liquid in 1975, have been filled and closed. Both dark-toned and light-toned mounded material is observed at these locations within the SLF.

Since 1975 a large landfarm area has been established on the eastern section of the RES facility. Five landfarm plots (Plot-1 through Plot-5) have been established along the south side of the access road that enters the RES facility from U.S. Route 61. Cleared areas and ground scars are observed along the north side of this access road but no landfarm activity is discerned. Within the landfarm area two basins (RW1* and RW2*) that now contain standing liquid and two clarifying tanks have been built to the north of LFM Plot-1. Drainage from the landfarm area appears to be captured by a system of ditches that empty into basins RW1 or RW2. The ditch D2S located west of the landfarm does not appear to receive runoff from the landfarm area.

Extensive earthmoving has occurred in the WLF. Several open cells noted as containing dark-toned liquid on the 1975 photograph have been filled and closed. Several cells including Cell 518*, which appears to contain solid waste and drums, and Cell 504*, which appears to contain sludge, have been opened. No bottom lining material could be discerned in any of the cells. Ground stains from spillage (not annotated) are also observed adjacent to several of these cells indicating poor housekeeping practices. Since 1975 the west landfill has been expanded to the northwest and new cells, including Cells 601*, 602*, 603*, and 604* have opened. Cell 601 contains dark-toned standing liquid or sludge and the other cells appear to be empty. No bottom lining material could be discerned in any of the cells.

Surface drainage from the west landfill flows west through drainage ditches and then south along the western perimeter of the RES facility. The western perimeter ditch trends south and then southwest around Cell 123B, before it empties into ditch D1 via a breach in a berm. The location of this breach is approximately the same location noted on the 1975 photograph where a ditch trended west around the former Cell 118 and then emptied into ditch D1.

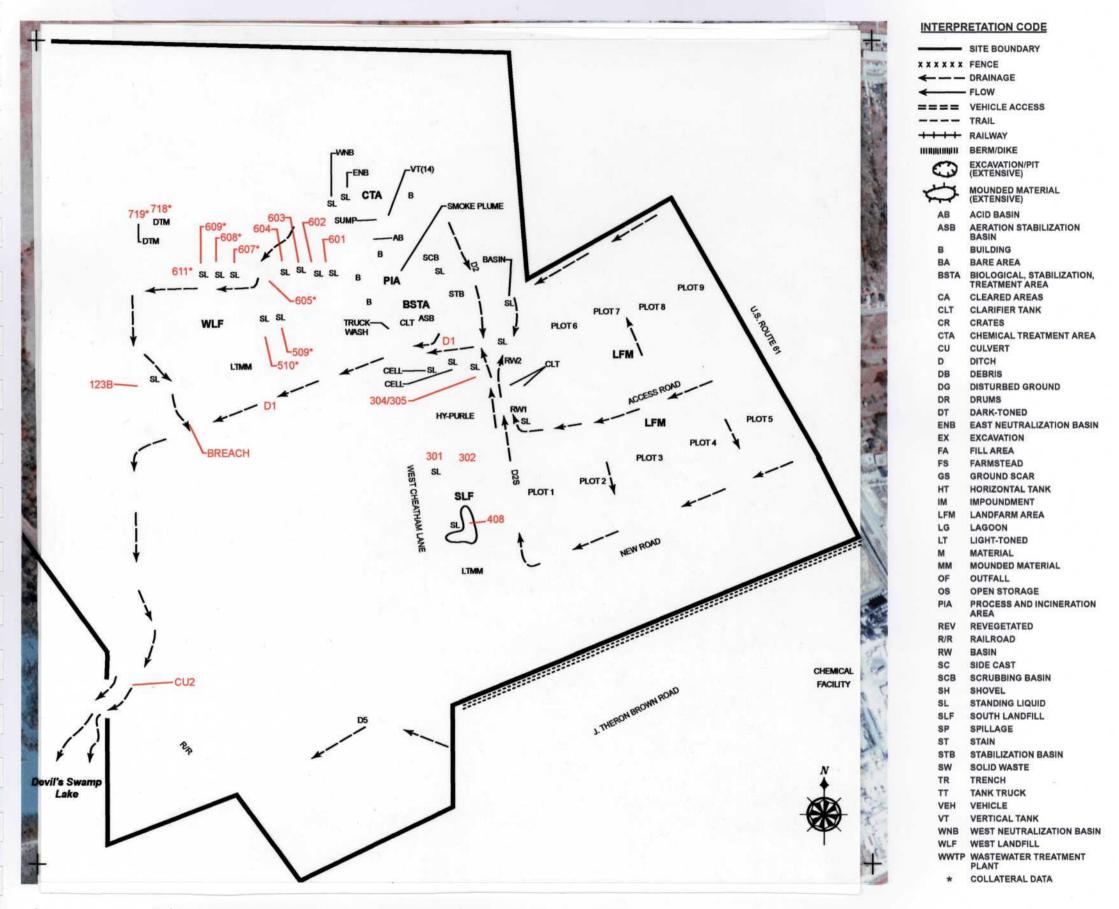
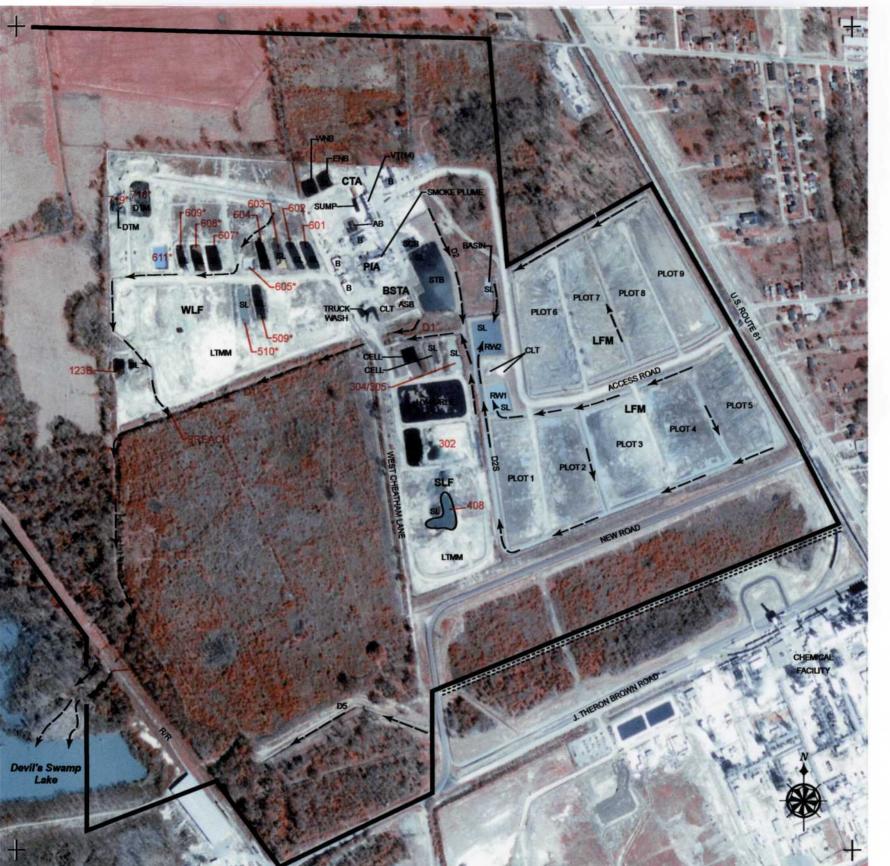
Figure 12. Devil's Swamp Lake area and RES site, March 3, 1980. Approximate scale 1:7,525.

The limited resolution of the high altitude color infrared 1980 photographs precluded the discernment of smaller features previously noted on earlier dates of photography. The portion of the site occupied by the RES facility has been enlarged to better show details of features within the RES facility.

The CTA within the RES facility remains operational and liquid is still noted in the basins WNB, ENB, and AB. The group of six lagoons last observed on the 1978 photograph has been removed.

Within the PIA a smoke plume is observed over the incinerator (not annotated) revealing ongoing incineration activities. Another building has been constructed along the western portion of the PIA.

The BSTA remains operational. Two additional liquid holding cells have been opened along the north side of the Hy-Purle cell. Cell 304/305 appears to have been merged into one cell. The Hy-Purle cell appears to hold a dark-toned liquid as does Cell 301. Cell 302 appears to hold a lighter-toned liquid. Probable tank trailers are still observed along the west side of the Hy-Purle cell (not annotated).

Within the SLF earthmoving activity is evident. Cell 408 now appears to contain liquid. A deposit of light-toned mounded material is observed at the south end of this landfill area.

Since 1978 several cells within the WLF, including Cell 504 and Cell 518 noted on the 1978 photograph, have been filled and closed. A large mound of light-toned material has been deposited southwest of Cell 510. Several new

Within the WLF surface runoff flows through a drainage ditch west and then south along the western perimeter. The western perimeter ditch trends south and then southwest around Cell 123* before it empties into ditch D1 via a breach in the south perimeter berm. The location of this breach remains at the same approximate location noted on the 1975 and 1978 photographs.

A new drainage ditch (D5) has been dug across the south perimeter of the site. Drainage ditch D5 appears to transport runoff and discharges from the offsite chemical facility located south of J. Theron Brown Road into Devil's Swamp Lake.

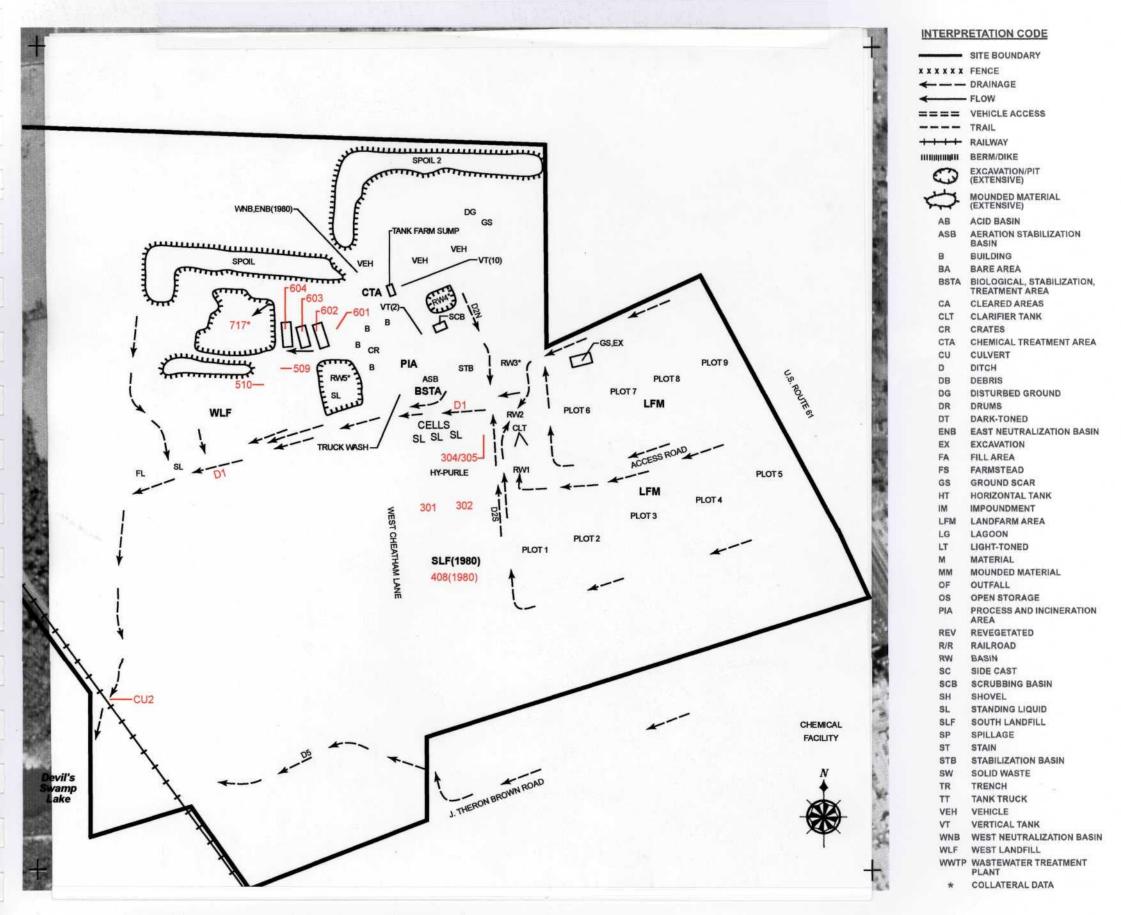
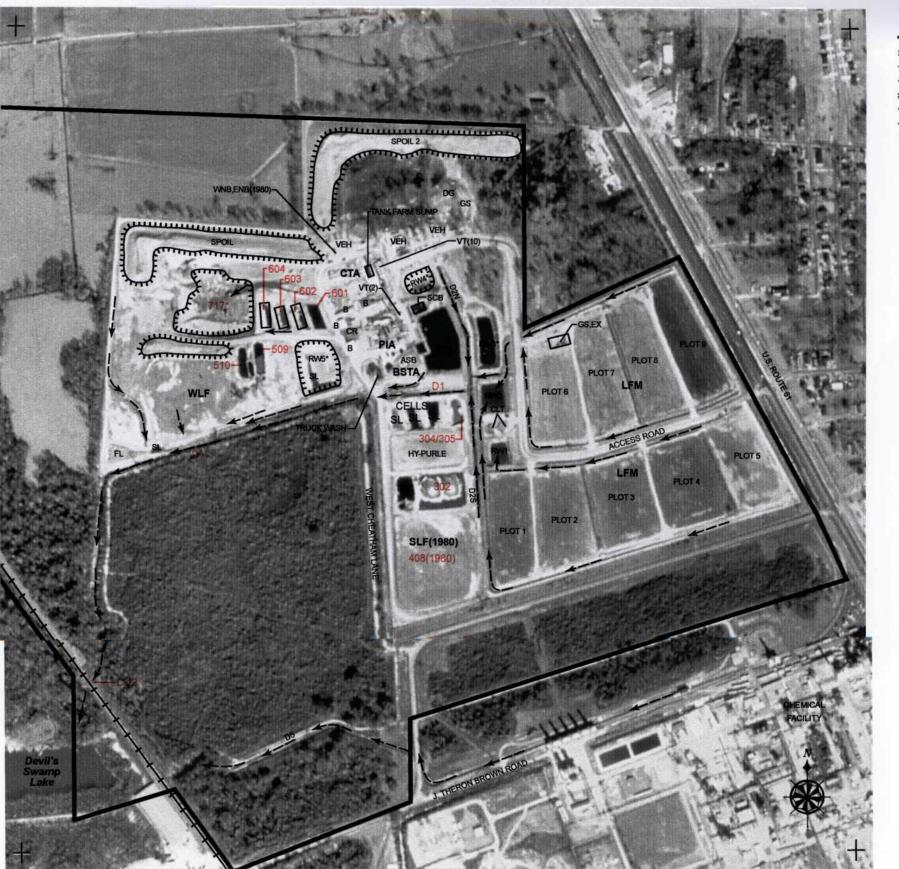
Figure 13. Devil's Swamp Lake area and RES site, January 27, 1982. Approximate scale 1:7,325.

Construction is noted at the CTA section of the RES facility. The two basins WNB and ENB have been filled and leveled. Ten tanks remain in the group of vertical tanks, four having been removed since 1980. The sump pit is still visible to the west of these tanks, but the acid basin (not annotated) formerly west of these vertical tanks has been filled and closed. Two other vertical tanks have been installed to the south in the PIA. Numerous vehicles are parked on the northeast side of the CTA. Since 1980 large mounds of spoil have been deposited north and northwest of the CTA.

Incineration operations within the PIA are uncertain because a smoke plume is not discerned over the incinerator (not annotated). An accumulation of boxes or crates is noted along the west side of the PIA.

earthmoving activity. Both light- and dark-toned dry material (not annotated) is visible at the bottom of Cell 717. A small amount of standing liquid is observed within RW5. No bottom lining material could be discerned in either basin RW5 or Cell 717. Several cells including Cells 509, 510, 601, 602, 603, and 604 are still visible and contain liquid.

Surface drainage from the northern portion of the WLF appears to flow into Cell 717. Surface drainage from the southern portion of the WLF continues to trend west and then south along the western perimeter to eventually empty into ditch D1.

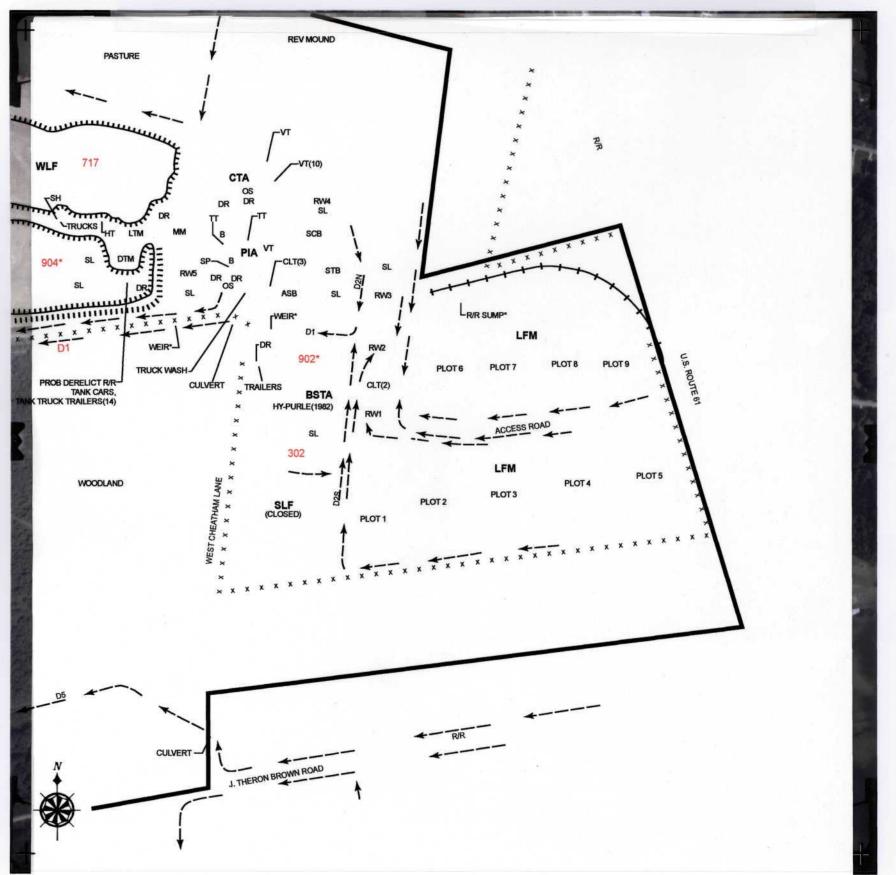
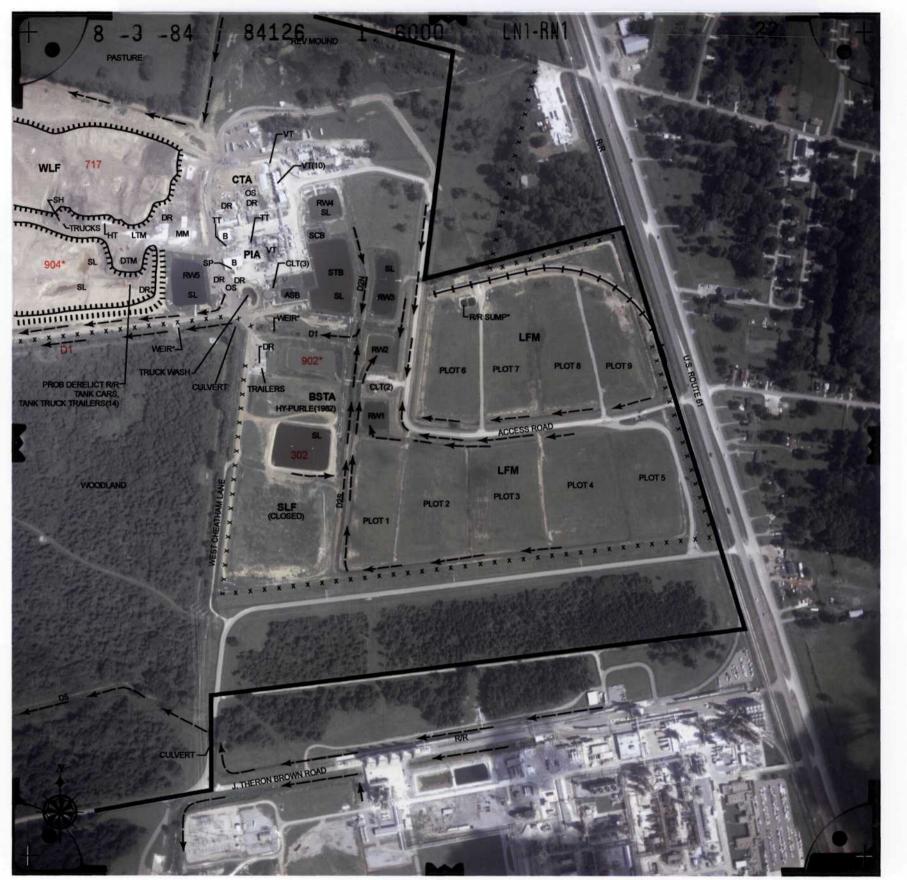
Figure 14. Devil's Swamp Lake area and RES site, August 9, 1984. Approximate scale 1:6,000.

The drainage ditches D1, D2N, and D2S appear operational and transport surface runoff and discharges away from the RES facility. A weir* is discerned along the section of ditch D1 east of West Cheatham Lane. A second weir* is discerned along ditch D1 west of West Cheatham Lane.

Only the eastern portion of the WLF is covered on this photograph. See the following photograph (Figure 15) for further analysis.

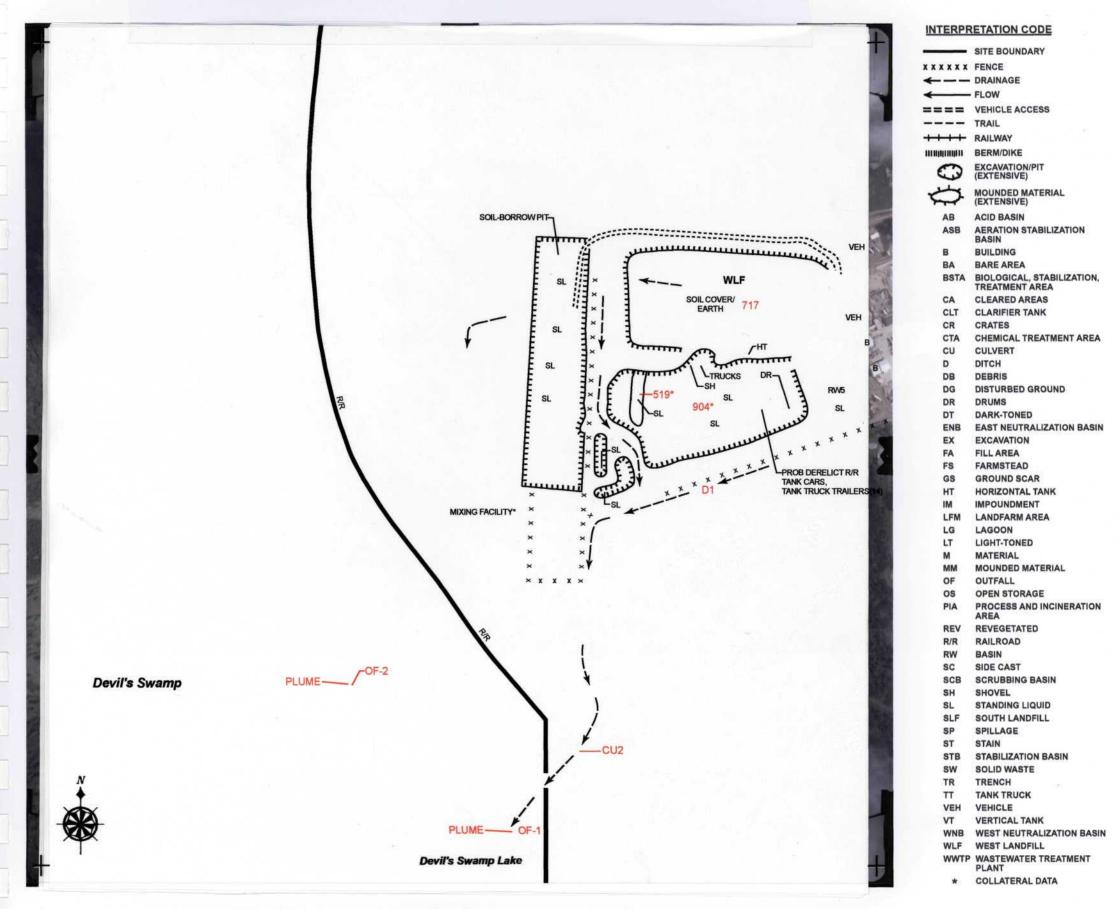
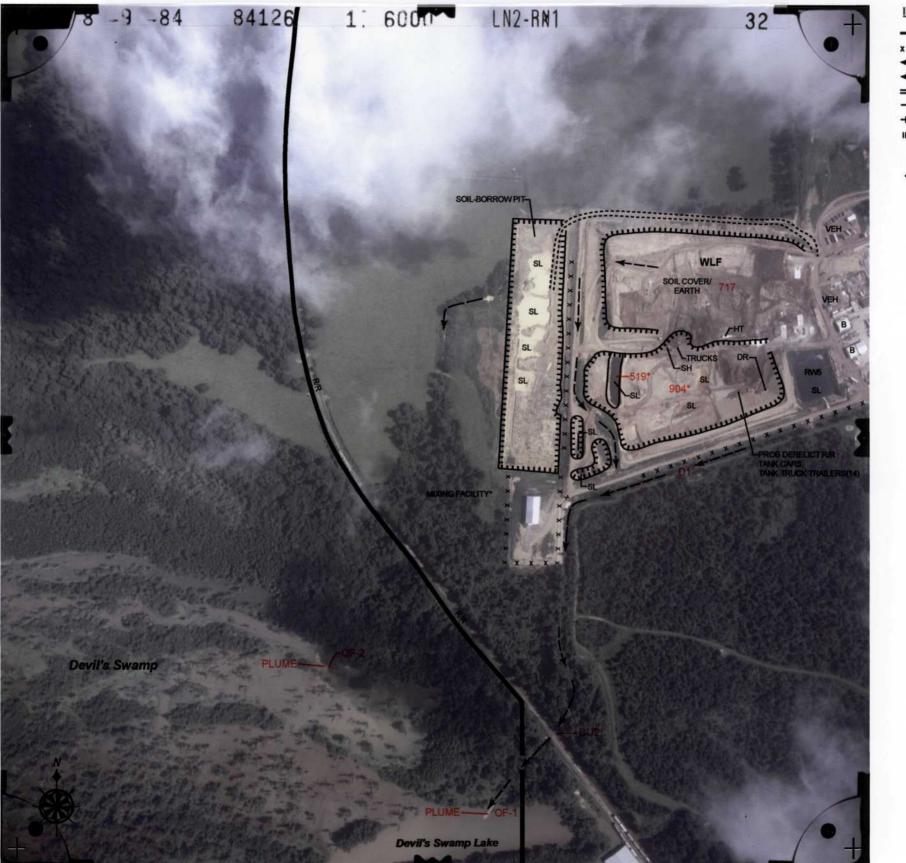
Figure 15. Devil's Swamp Lake area and RES site, August 9, 1984. Approximate scale 1:6,000.

Drainage from the northern portion of the WLF continues to trend west and then south, around Cell 904, and eventually empties into ditch D1. Surface drainage from the southern portion of the WLF generally flows into Cell 904.

Only the northern portion of Devil's Swamp Lake is covered on this photograph (see also Figure 16). Two outfall plumes (OF-1 and OF-2) are observed flowing into Devil's Swamp Lake southwest of the WLF and soil-borrow pit. The source of these outfalls likely came from the RES facility via culverts under the railroad along the west perimeter of the site.
